HARTWELL LAKE PROJECT
Savannah River, Georgia And South Carolina

REHABILITATION OF CLEMSON UPPER DIVERSION DAM

CONTRACT NO. DACW21-83-C-0066

CONSTRUCTION FOUNDATION REPORT

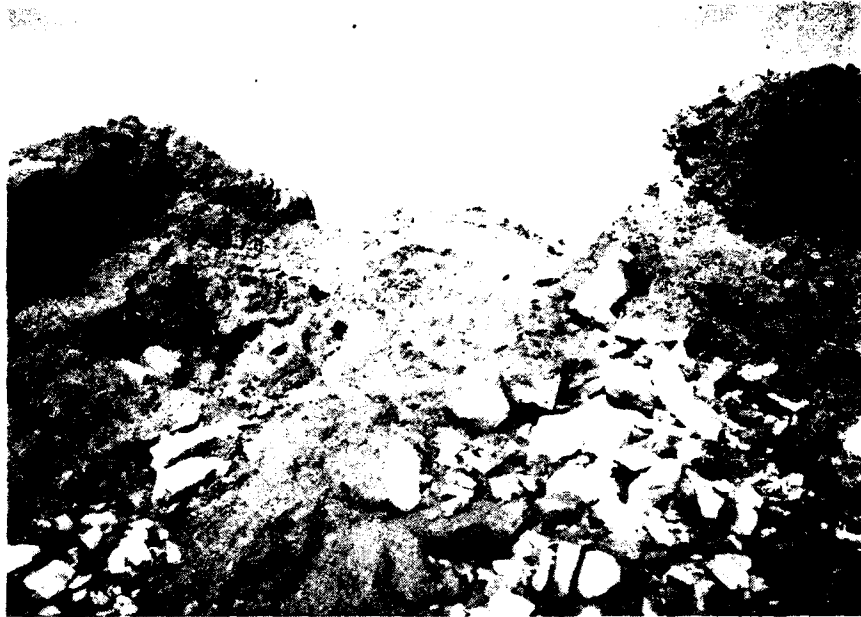
Photo 33 - Overflow of bentonite slurry looking toward Highway 93
from desander (February 10, 1984)

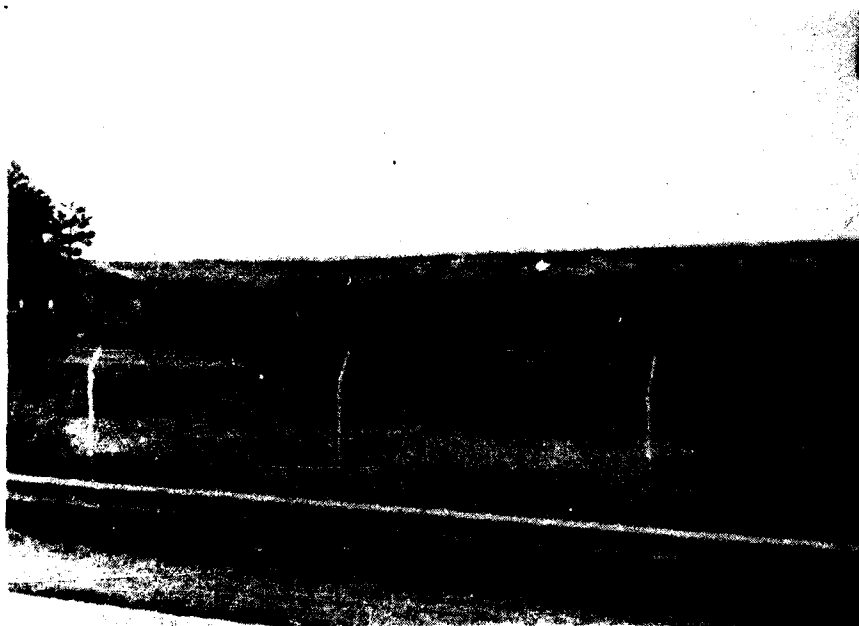
Photo 81 - Overview after site restoration (November 1985)
